FHWA/IN/JHRP-93/2-2
Final Report

PAVEMENT DRAINAGE AND PAVEMENT-
SHOULDER JOINT EVALUATION &
REHABILITATION

March 1993
Revised February 1994

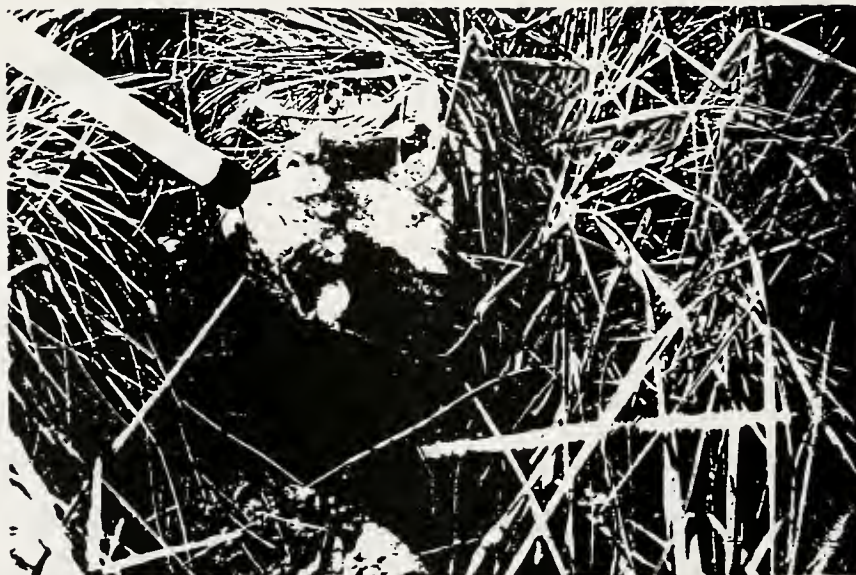
Figure 3.11 View of crushed outlet pipe

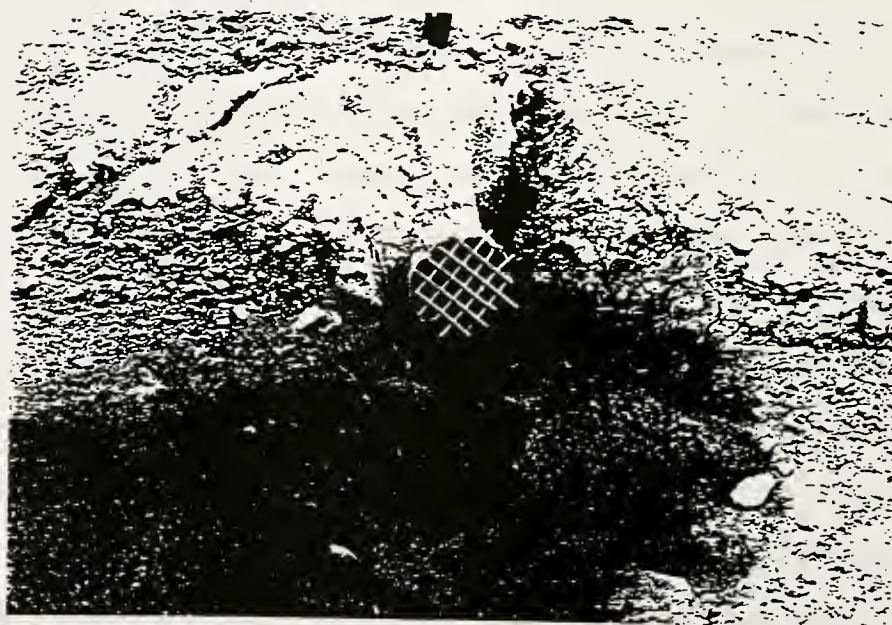
Figure 3.16 Erosion around newly constructed outlet pipe

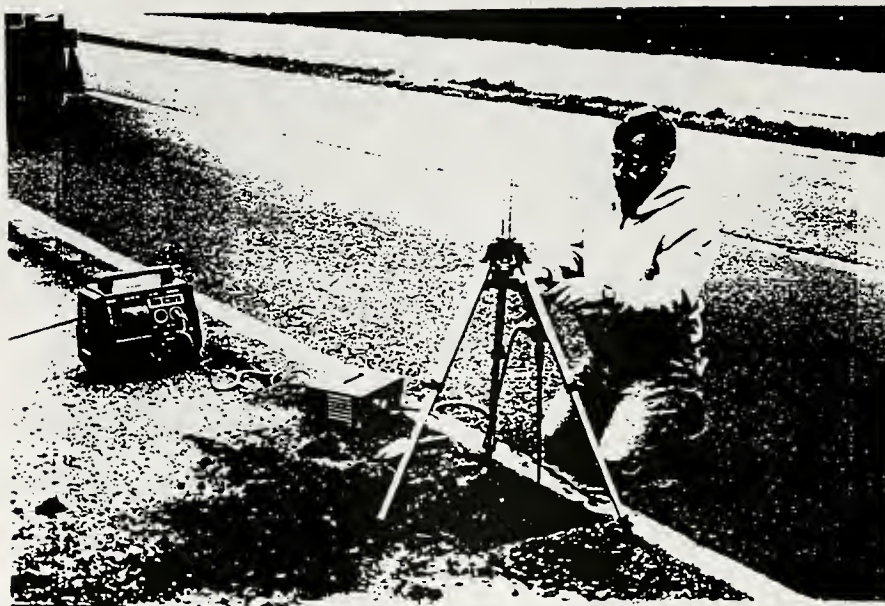
Figure 3.17 Setup of Olympus borescope system

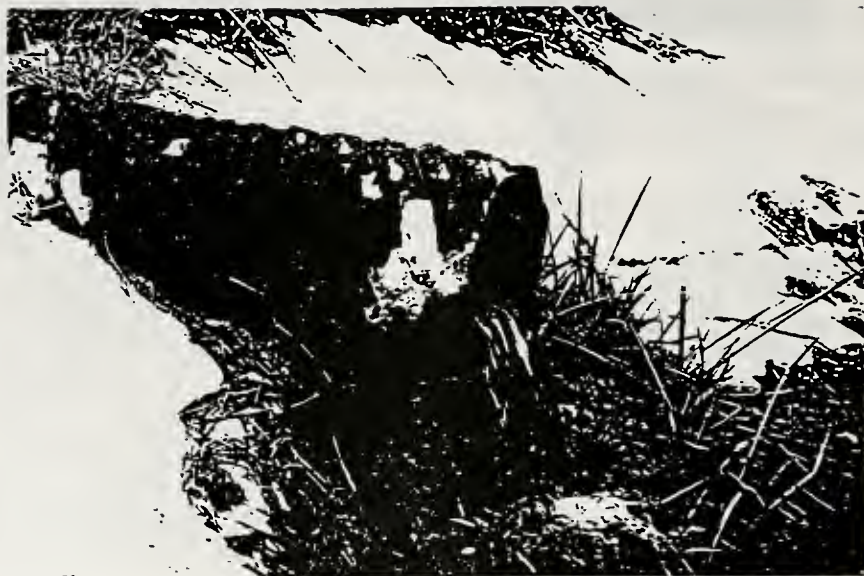
Figure 3.18 Water flowing freely from an outlet pipe

In newer sections, those built within the last two or three years, water was found to be flowing freely both inside the underdrain and the outlet pipes. In older sections,

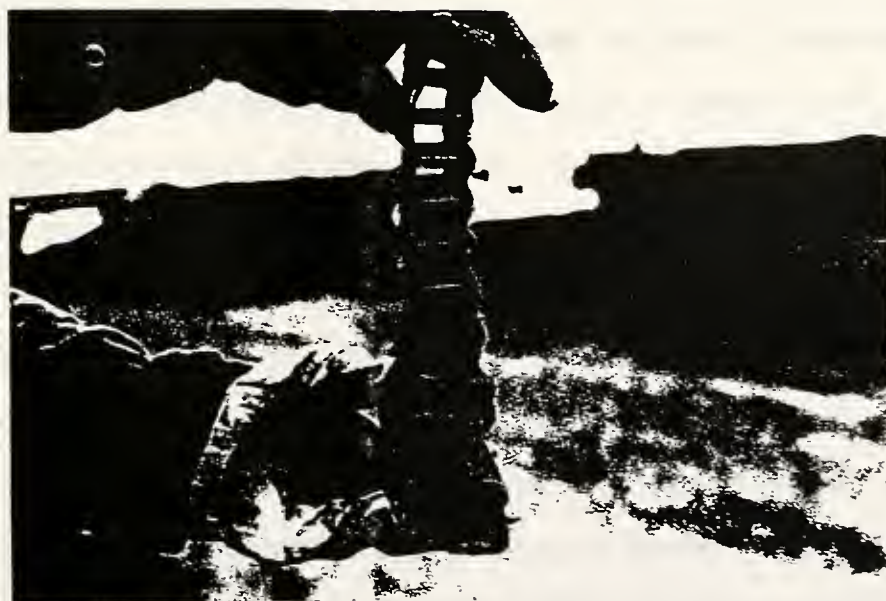
Figure 3.23 Exposed fin drain indicating J-Buckling

Buckling was observed at most points along the fin drains with the aid of the borescope camera. The cuspatations of the drain core would seem to arch along the horizontal plane. This was more pronounced at transverse joints along concrete

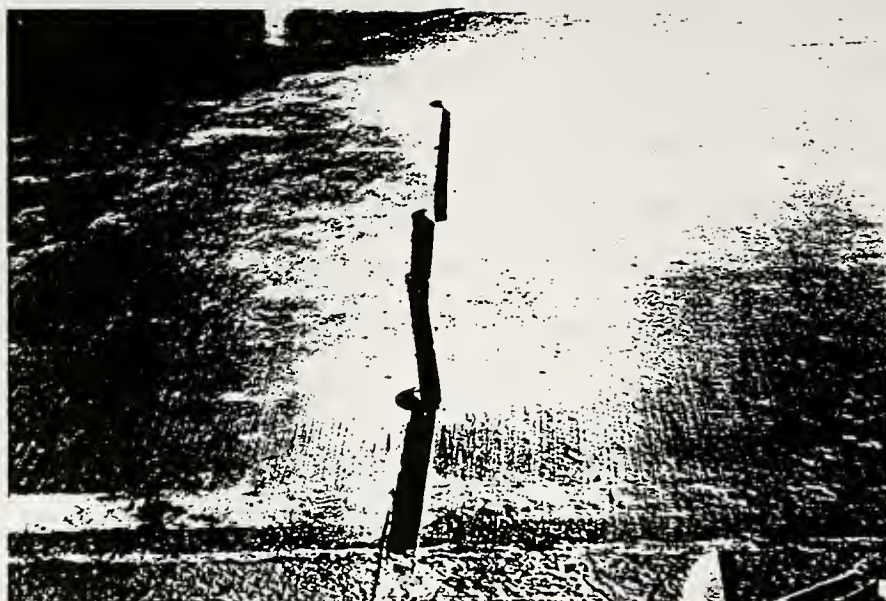
Figure 4.11 Sawcut in pavement for routing wires to datalogger
